MICE Spectrometer Solenoid Repair

MICE Spectrometer Solenoids

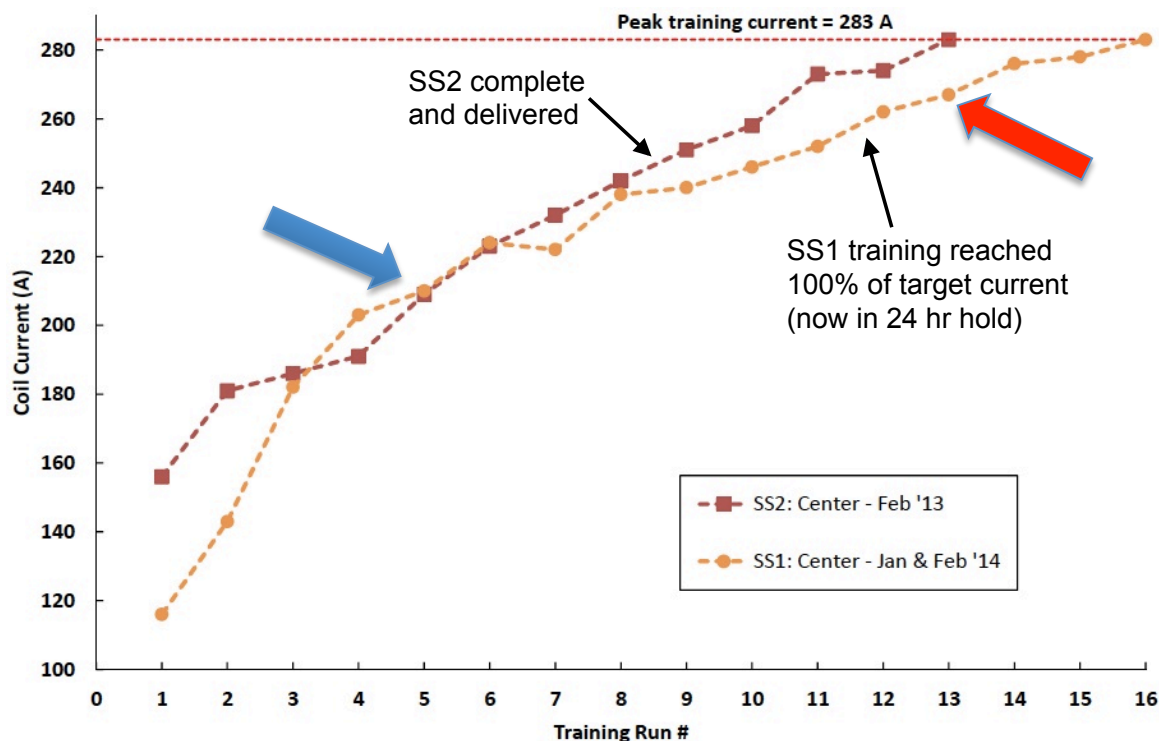
SS1 Training Progress

- SSD has been a bit problematic at RAL
 - Some vacuum issues
 - Lost voltage tap on LTS lead of M2 coil
- In the training run of September 11th, 2015 all was going very well.
 - Implementation of additional QP for the M2 lead had not yet been done, so the decision was made to ramp only M1 and ECE
 - A quench occurred at $\sim 260\text{A}$ in ECE (much higher than expected, next slide).
- QP system performed as expected, nothing outwardly unusual except for the large current.

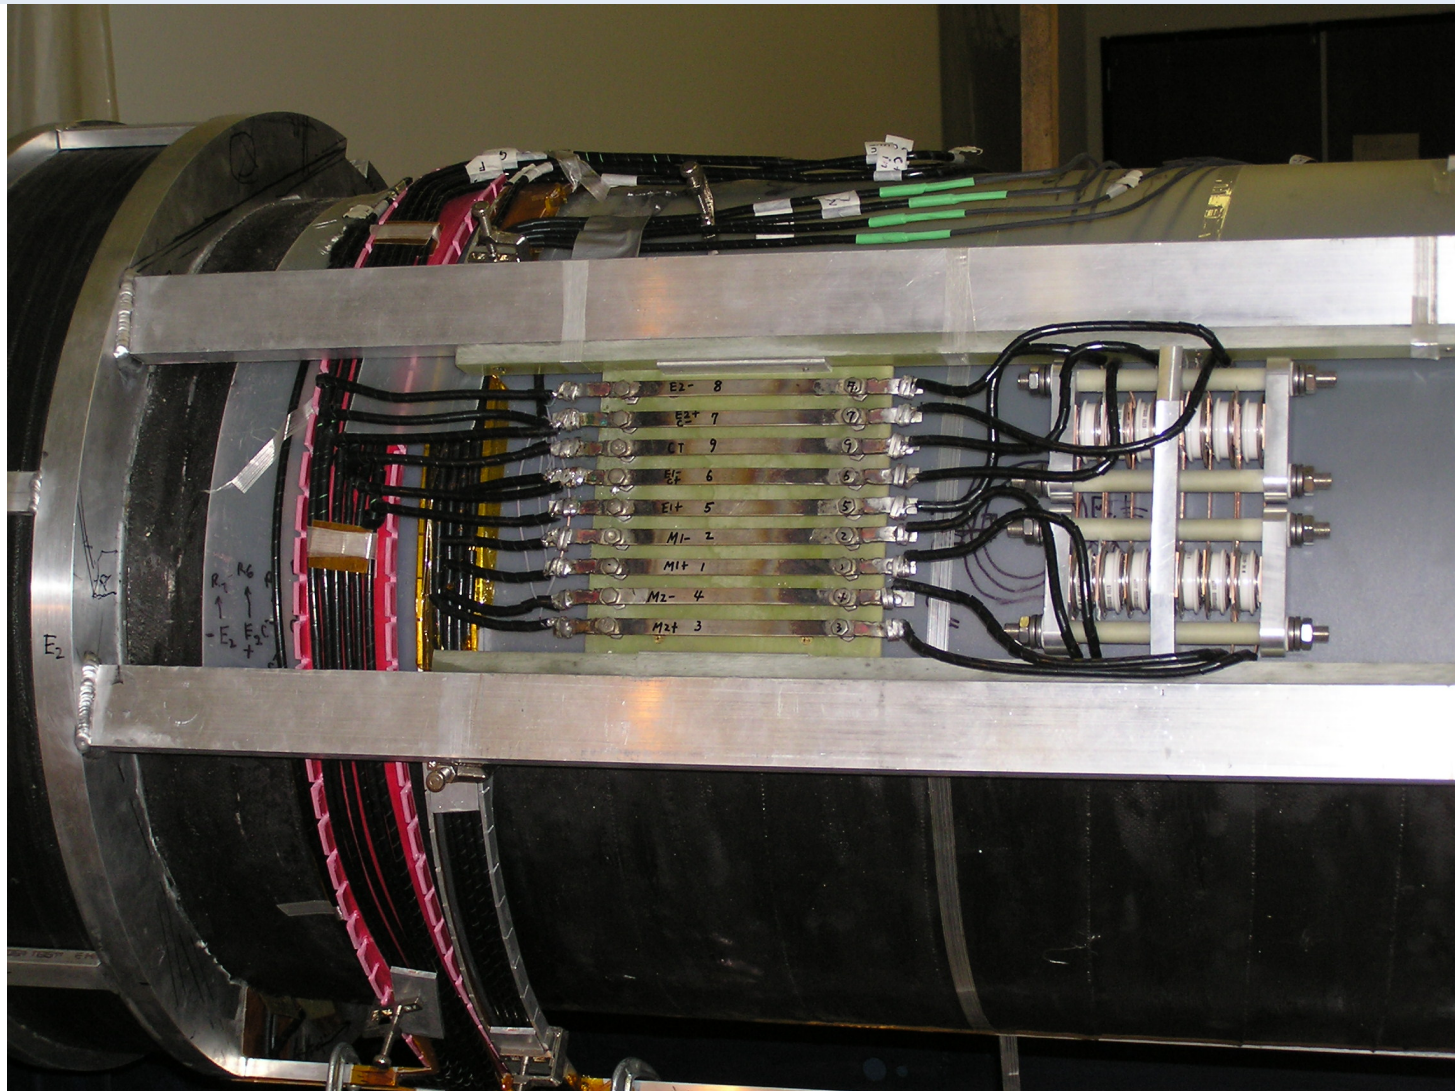
Original Wang configuration

- Quench initiated on ECE and initially proceeded normally
 - There is no evidence that any LTS leads were involved initially
- At ~ 20 sec, the internal QP for coil M1 failed
 - The voltage on the coil increased rapidly and, it appears that an arc at the LTS power feed through (from vacuum to LHe volume) occurred which burnt out the lead and effected M2 (the power leads for M1 and M2 utilize the same 4 pin feed through).
- What caused the QP failure?

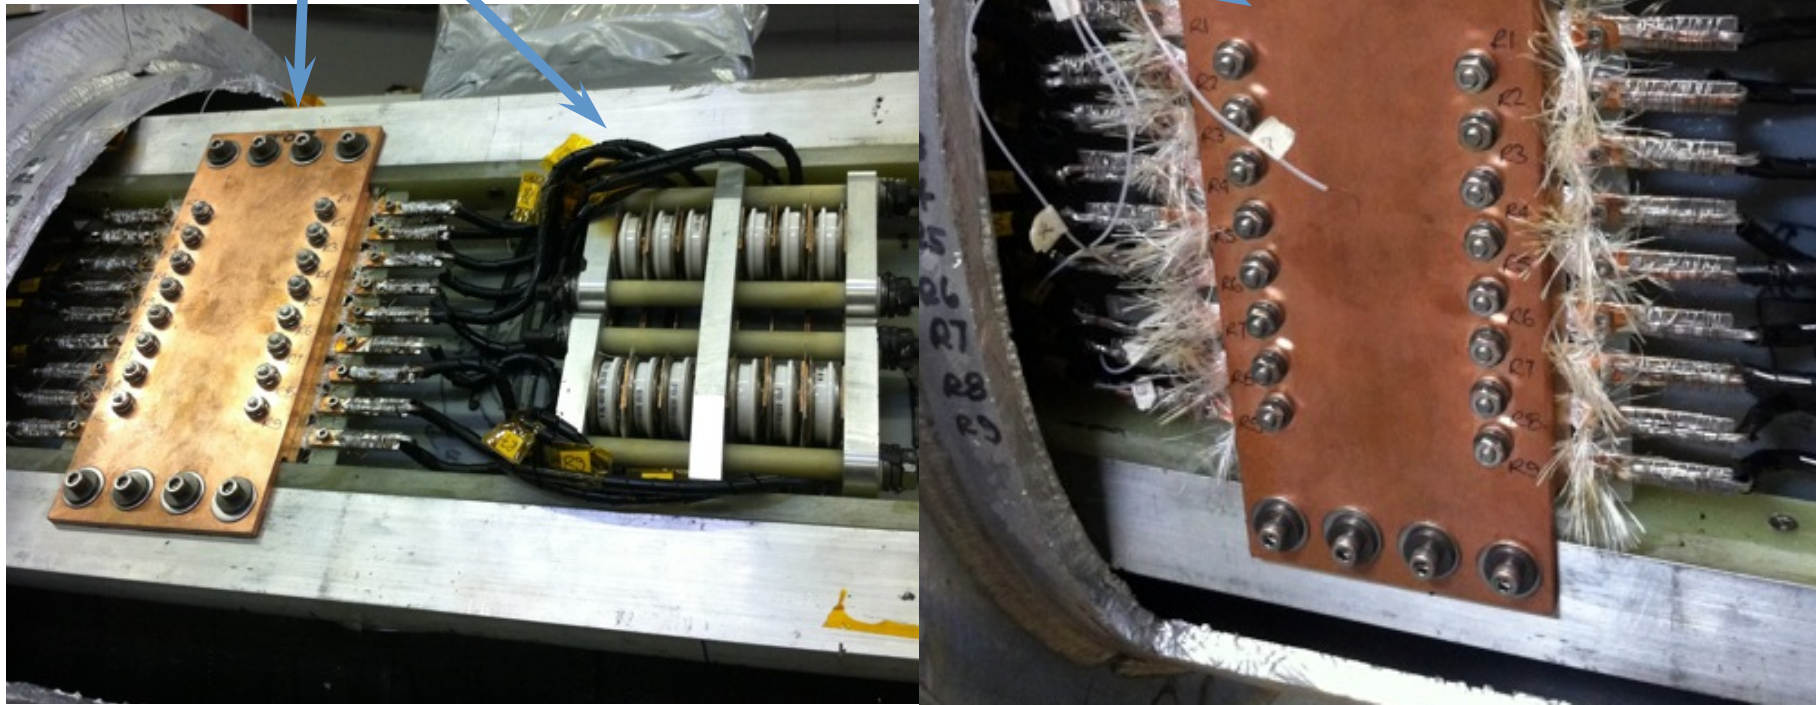
Quench protection circuitry

Conductively cooled resistors

- A. Do nothing & hope SSD-M2 has a long and prosperous life
- B. Run Step IV (to end or M2 failure) and then cut into SSD to repair
 - There are a number of sub-options here
 - Risk of compromising cold-mass supports
- C. Run Step IV (to end or M2 failure) and then pull cold mass and repair and replace
 - Maybe the most straight forward option, but potentially longest calendar time
- D. Immediately start process to build new cold mass (we have SC) with upgraded design and fully train in stand-alone cryostat (Training issues, Power feed throughs, QP)
 - Disassemble SSD (at end of Step IV or M2 failure) and integrate vacuum vessel, cryo-system, shields, etc. with new cold mass.
And yes, be ready by June, 2017
- E. +???
